INSTALLATION DETAILS: FOR OLDCASTLE - RELIANCE CASSETTE - VHB (CW)

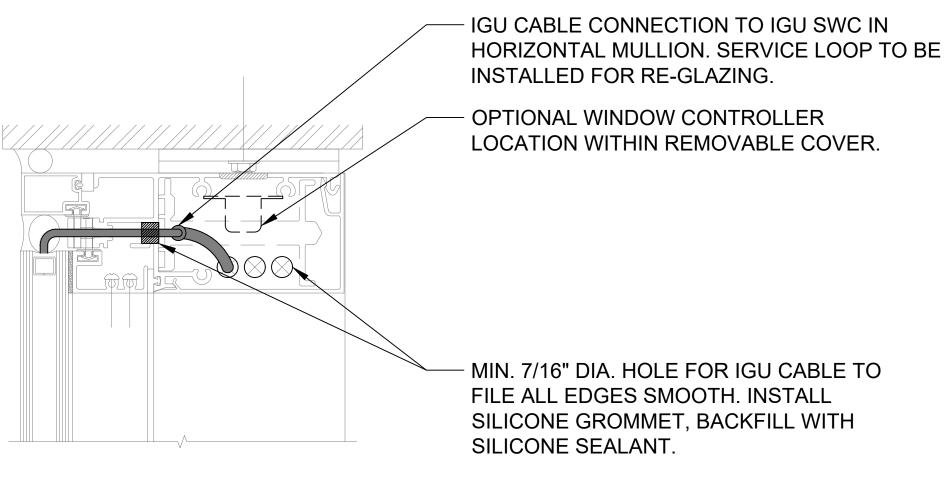
DETAIL 1 HEAD

AT ALL FRAME PENETRATIONS WHERE POSSIBLE TO AVOID CABLE DAMAGE.

INSTALLER TO PROVIDE GROMMETS

- WHEN GLAZING POCKET CANNOT ACCOMMODATE IGU/SWC, INCORPORATE SERVICE LOOP INTO IGU CABLING. MAKE CONNECTION TO SWC AS YOU ARE GLAZING AND PUSH CONNECTOR THROUGH HOLE AND INTO MULLION.
- NO WIRE ROUTING IN SILL

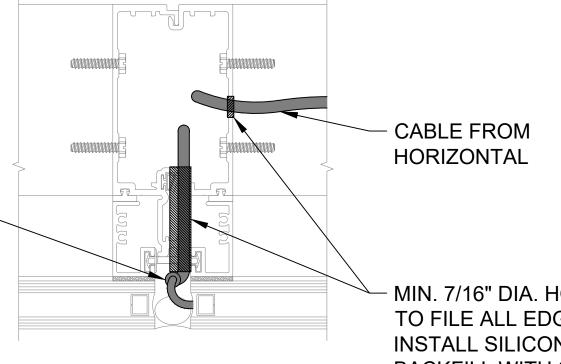
DETAIL 5 VERTICAL MULLION SCALE: NONE

IGU CABLE CONNECTION TO IGU SWC IN BUTT JOINT. INSTALL SMALLER BACKER ROD TO ACCOMMODATE AS REQUIRED.

MIN. 7/16" DIA. HOLE FOR IGU CABLE TO FILE ALL EDGES SMOOTH. INSTALL SILICONE GROMMET, BACKFILL WITH SILICONE SEALANT.
